THE PORT AUTHORITY OF NEW YORK AND NEW JERSEY

To: August Preschle, Manager, World Trade Center Operations
From: Harry R. Pool, Jr.
Date: March 24, 1988
Subject: THE WORLD TRADE CENTER - ASBESTOS INVESTIGATION AND ANALYSIS REPORT
Copy to: F. Boyce, N. Budeiri, D. Darcy, J. Davison, D. Hahn, P. LaRocco, D. Leahy, R. Linn, P. Maurer, D. Moncalbano, J. Pearse, S. Samperi, V. Strom

ASBESTOS INVESTIGATION AND ANALYSIS REPORT
WORLD TRADE CENTER
VOLUME I OF II

ENVIRONMENTAL MANAGEMENT DIVISION
MARCH 21, 1988

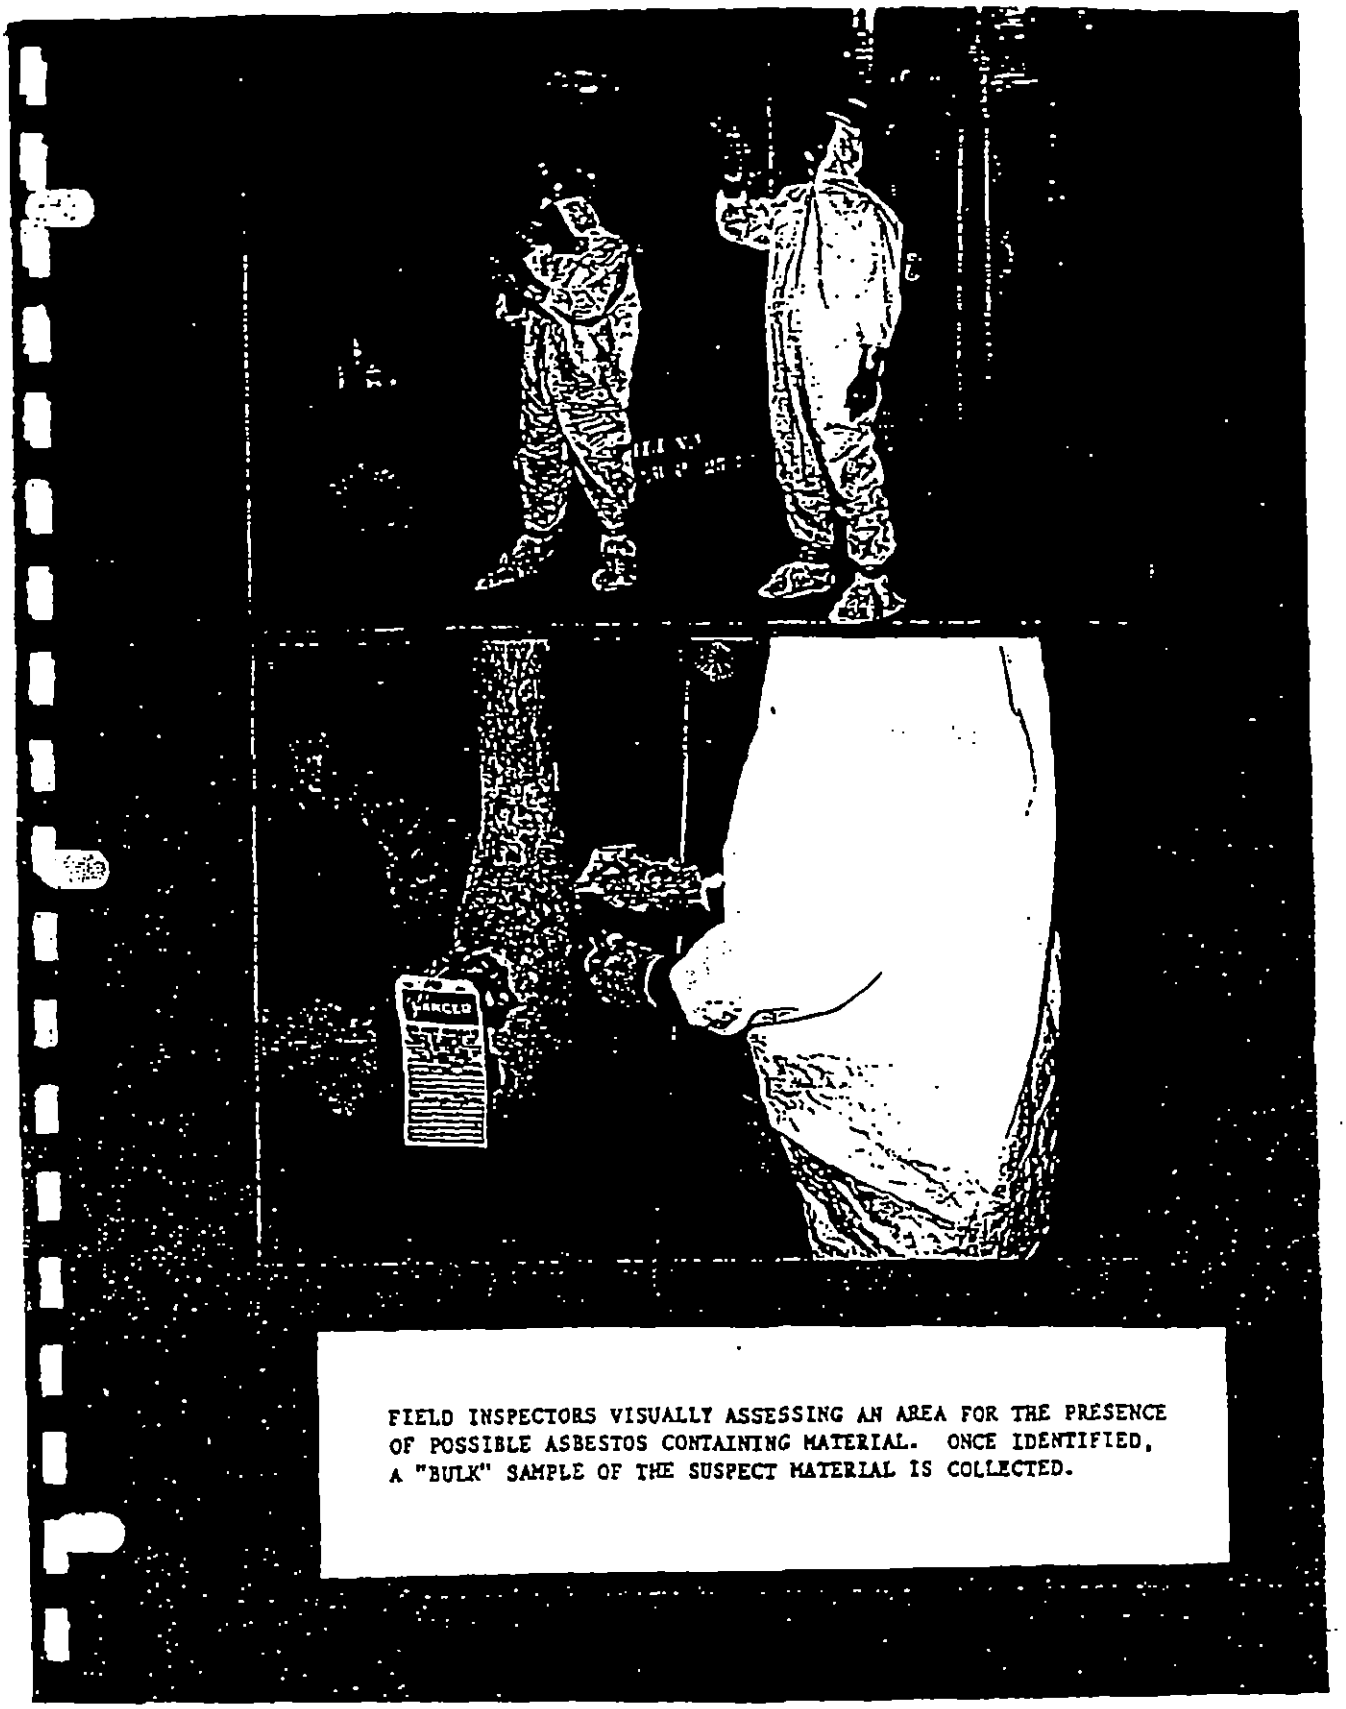
FIELD INSPECTORS VISUALLY ASSESSING AN AREA FOR THE PRESENCE OF POSSIBLE ASBESTOS CONTAINING MATERIAL. ONCE IDENTIFIED, A "BULK" SAMPLE OF THE SUSPECT MATERIAL IS COLLECTED.

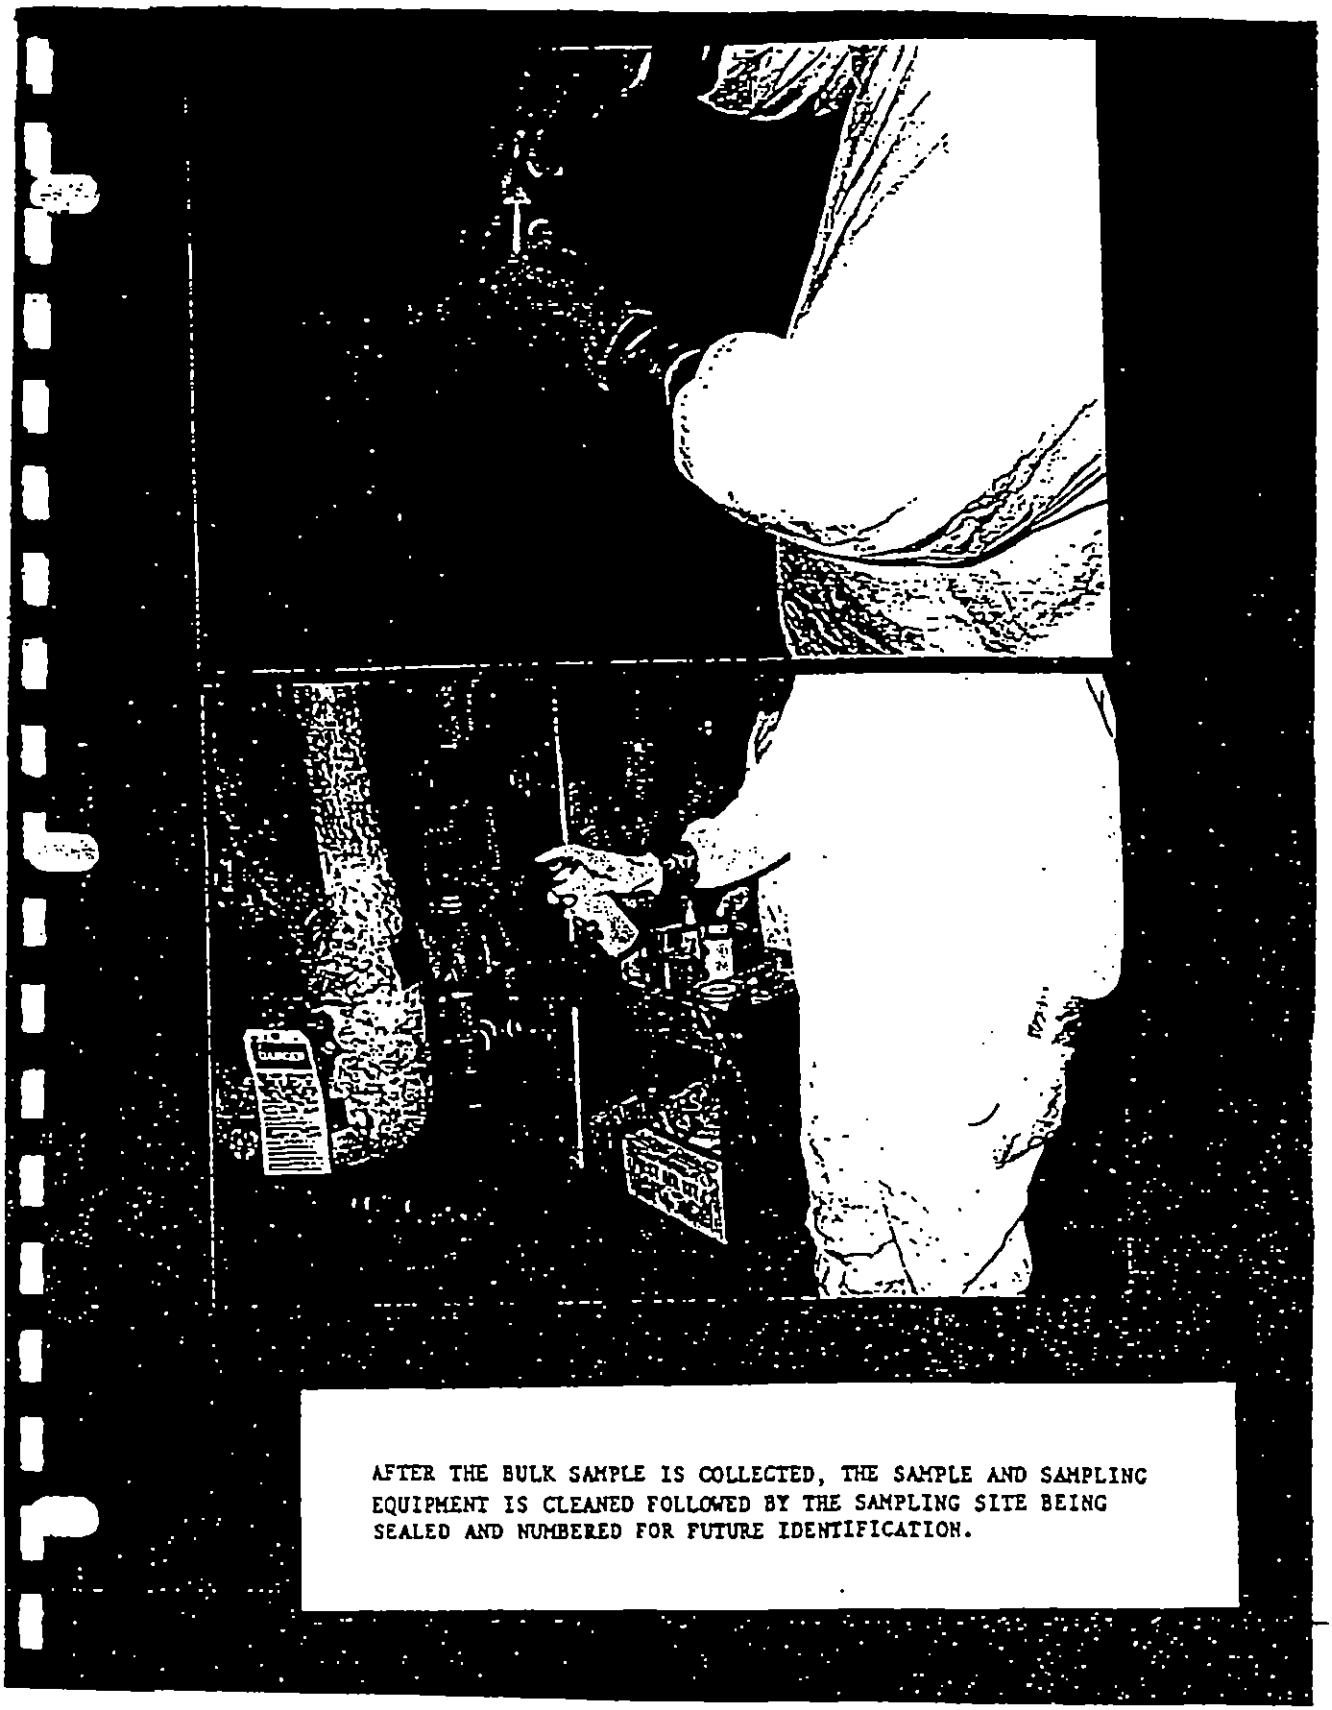
AFTER THE BULK SAMPLE IS COLLECTED, THE SAMPLE AND SAMPLING EQUIPMENT IS CLEANED FOLLOWED BY THE SAMPLING SITE BEING SEALED AND NUMBERED FOR FUTURE IDENTIFICATION.

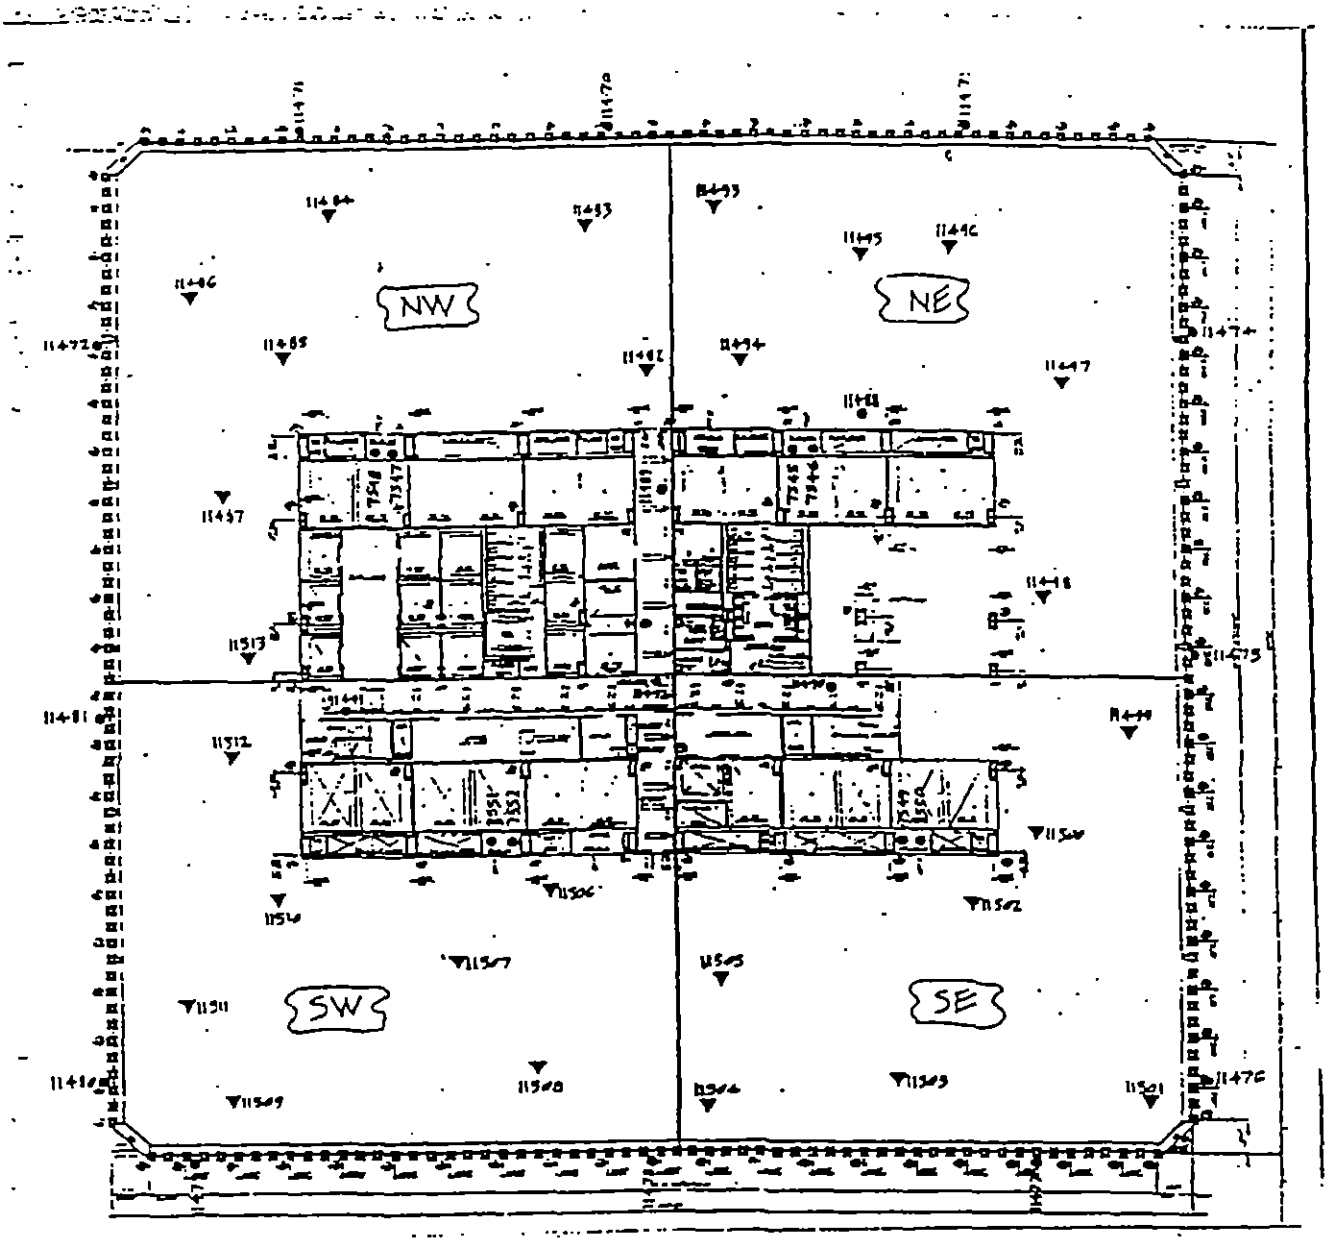
OPERATIONS AND MAINTENANCE AREA

THIS TYPE OF ASBESTOS CONDITION IS FREQUENTLY FOUND WHERE THE ACM IS USUALLY INSTALLED IN A LOCATION THAT IS NOT DIRECTLY ACCESSIBLE TO EMPLOYEES OR THE PUBLIC. HOWEVER, FOR OPERATIONAL OR MAINTENANCE PURPOSES EMPLOYEES MAY BE REQUIRED TO WORK IN CLOSE PROXIMITY AND INCREASE THE RISK OF DISTURBANCE TO THE ASBESTOS. IN THESE AREAS, WORKERS AND BUILDING OCCUPANTS MUST BE ALERTED TO THE LOCATION OF THE ACM AS APPLICABLE; PERSONNEL MUST BE TRAINED IN PROPER CLEANING, MAINTENANCE, REPAIRS, AND RENOVATIONS; AND ALL SUCH AREAS MUST BE PERIODICALLY REINSPECTED BY THE FACILITY.
